MONUMENT TO GEORGE INGLIS CHATAK

GEOLOGICAL SURVEY OF INDIA.

VOL. XXIX.

REPORT	on the GREAT EARTHQUAKE of 12TH	JUNE	1897,	by
R. D	. OLDHAM, A.B.S.M., F.G.S., Superinten	dent.	Geolos	rical
	ey of India.	,	c	,
	1			
	n some general principles of Seismology .		•	v
	-Introductory		•	1
	-Narrative accounts of the nature of the shock		•	4
Chapter III	The isoseismic lines and area over which the sl	lock wa	ıs felt	42
Chapter IV	The rate of propagation, and time of the co	menc menc	ement	
	of the shock	•		53
	—The rate and range of motion of the wave particl		•	78
Chapter VI	Earth fissures, sand vents and allied phenomen	a .		85
Chapter VI	I.—The landslips	•		III
Chapter VI	II.—The aftershocks	•		124
Chapter 1X	Results of an exploration of the epicentral tract			129
Chapter X.	-The position and extent of the seismic focus	,		164
Chapter X1	The records of the Bombay Magnetic Observat	ory .		180
Chapter X	II.—Electric effects			189
	III.—The earthquake sounds, with some remarks o	n the E	Jarisal

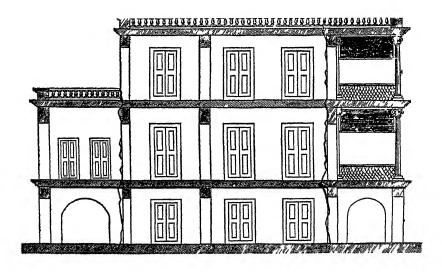
Fig. 3. Typical Section of a Calcutta House.

Figure 3 represents the transverse section of a typical Calcutta house. There is a central portion built with thick walls, with flat cemented roof and cemented or marble floors to each story; on the south is a broad verandah, where the roof and floors are carried by

tall brick pillars, the upper half of the openings being filled by wooden venetian blinds; on the north is a large porch, often with a room built over it, as shown in the figure, but sometimes without

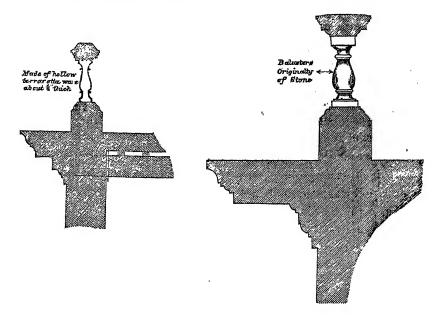
Fig. 4. Section of roof, cornice, and parapet of a private house, Calcutta.

Another cause of the damage in Calcutta was the heavy and weak balustrades and cornices found on most of the older houses. These will be noticed in the views reproduced on Plates XXIII and XXIV,

and are represented in section on figures 4 and 5, for which I am indebted to the courtesy of Messrs. Macintosh, Burn and Co. Figure 4 represents in section the roof, cornice and balustrade of an ordinary private house; fig. 5, that of the Calcutta Town Hall, which may be regarded as an extreme case of this type of construction. The balustrade, whose general appearance can be seen on Plates XXIII and

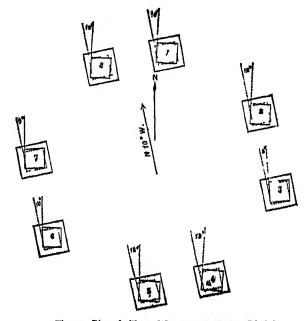
Fig. 24. Plan of pillars of thermometer shed at Dhubri.

7(a). The thermometer shed is in front of the observatory building. A plan
Thermometer shed.

of this is given in fig. 24. It consists of a thatched roof
up ported by eight brick pillars, each of which is cracked
through near the base and twisted in the direction of the hands of a watch
from 5 to 12 degrees.

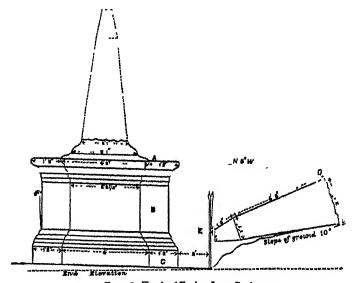
Fig. 26. Tomb of Ensign Law, Goalpara.

Ensign Law's tomb is of the same shapegenerally, but was surmounted by an obelisk 5 feet 8 inches high, which broke off at its plane of junction with the top of the tomb and was thrown to N 5° W. As it fell, it must have

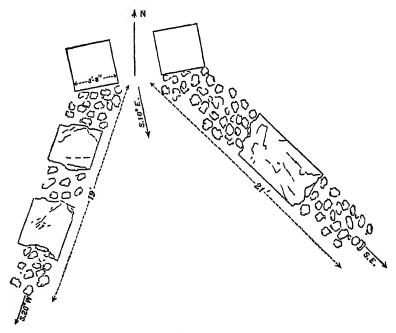
Fig. 28, Plan of overturned gate pillars at entrance to Inglis' house, Cherrapunji. (272)

54. At the entrance to the avenue leading to Mr. Inglis' house stood two lofty Mr. Inglis' house gate gate pillars, which formed a conspicuous object in the land pillars.

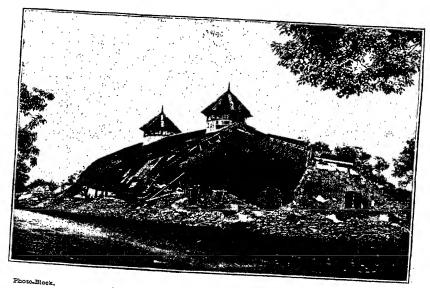
23. Both the cutcherries were wrecked, but a great portion of the roof of Commissioner's and Deputy Commissioner's cutcherry is shown in Plate XX, fig. 2. The roof of this was partly supported by strong wooden posts. The Deputy Commissioner's cutcherry (Plate XX, fig. 1) is in the form of a cross with equal arms facing the four points of the compass. The roof was partially supported by round brick pillars, which, though cracked through, have not fallen. The weathercock, seen in the photograph, was an effigy of a peacock and has tilted over to the north, so that its tail is hauging down beside the rod supporting the letter N.

FIG. 1. DEPUTY COMMISSIONER'S CUTCHERRY, GAUHATI.

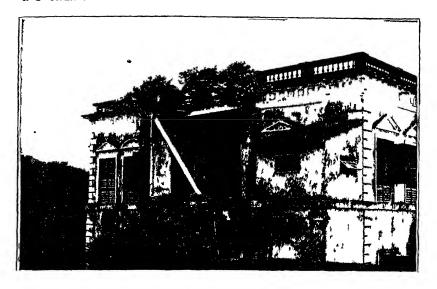
FIG. 1. No 114 CIRCUIAL LOAD, CAICULIA

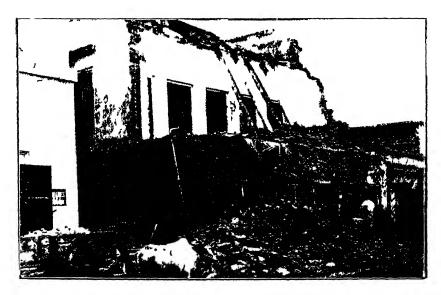
FIG 2 HOUSE IN BENTINCK STREET, CALCUTTA.

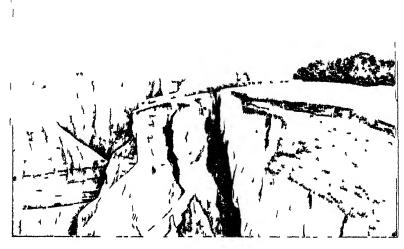
FIG. 2. BRIDGE OVER CANAL AT RANGPUR.

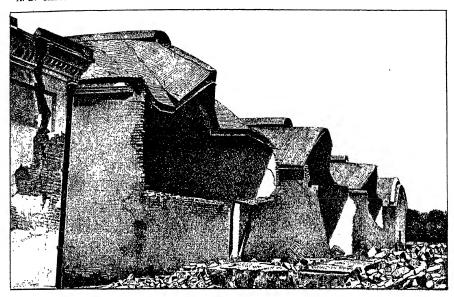
FIG. 1. GODOWNS OF JUTE MILL, SERAJGUNJ.

FIG. 2. MANAGER'S BUNGALOW JUTE MILL, SERAJGUNJ.

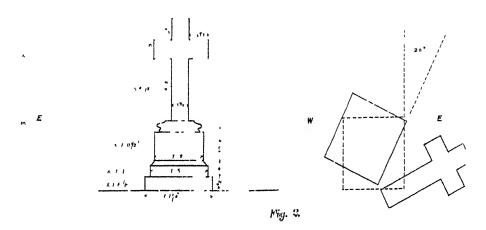
PLANS OF DISTURBED TOMBS

THE SHILLONG CEMETERY.
